**DOT/FAA/TC-22/35**

# **Small Unmanned Aircraft System for Pavement Inspection: Task 4—Execute the Field Demonstration Plan and Analyze the Collected Data**

November 2022

Final Report

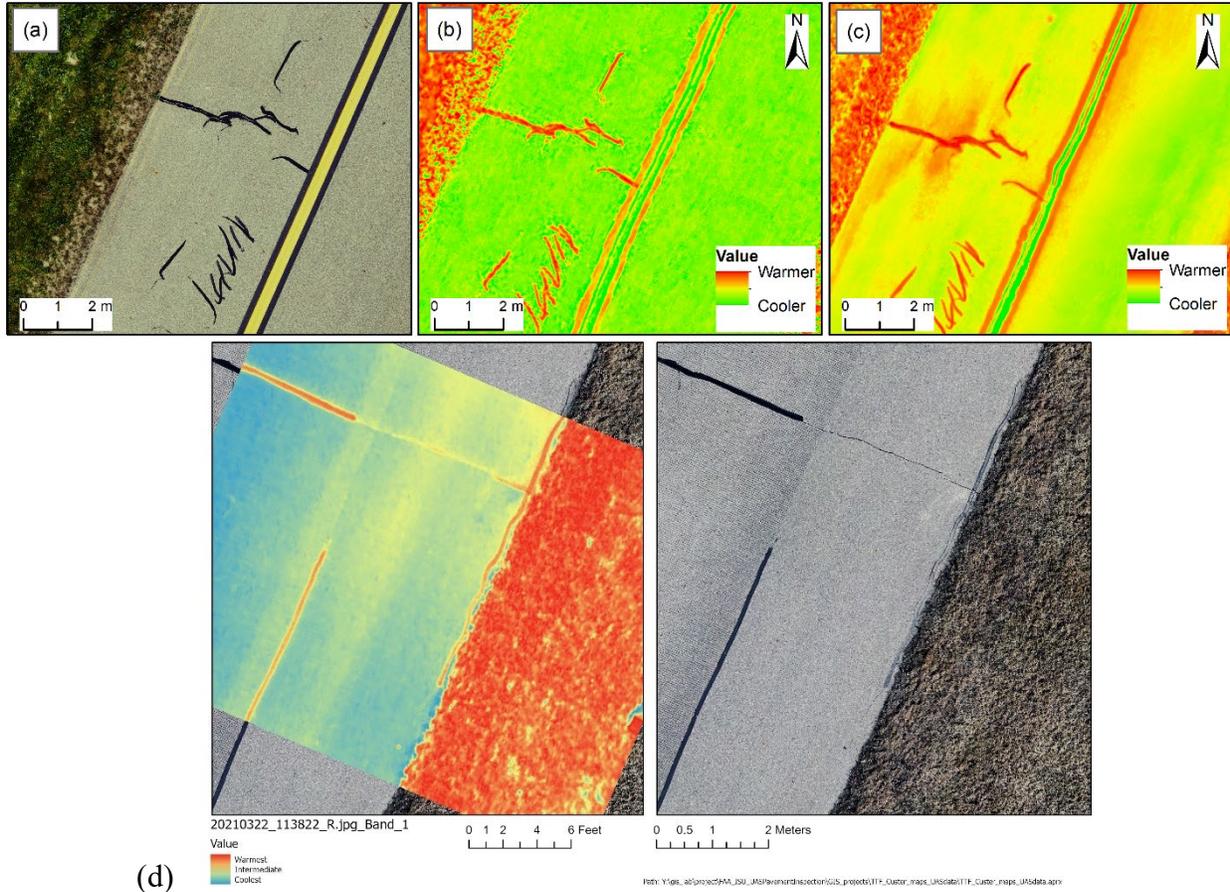
Figure 27. Sealed L&T Cracks on AC Pavement in Taxiway A Sample Unit 23 at TTF: (a) 1.5-mm/pix Orthophoto, (b) 31-mm/pix Stereo Thermal, (c) 14-mm/pix Stereo Thermal, and (d) Alternate View of Cracks in the 14-mm/pix Stereo Thermal Results Compared to an Orthophoto of the Same Area

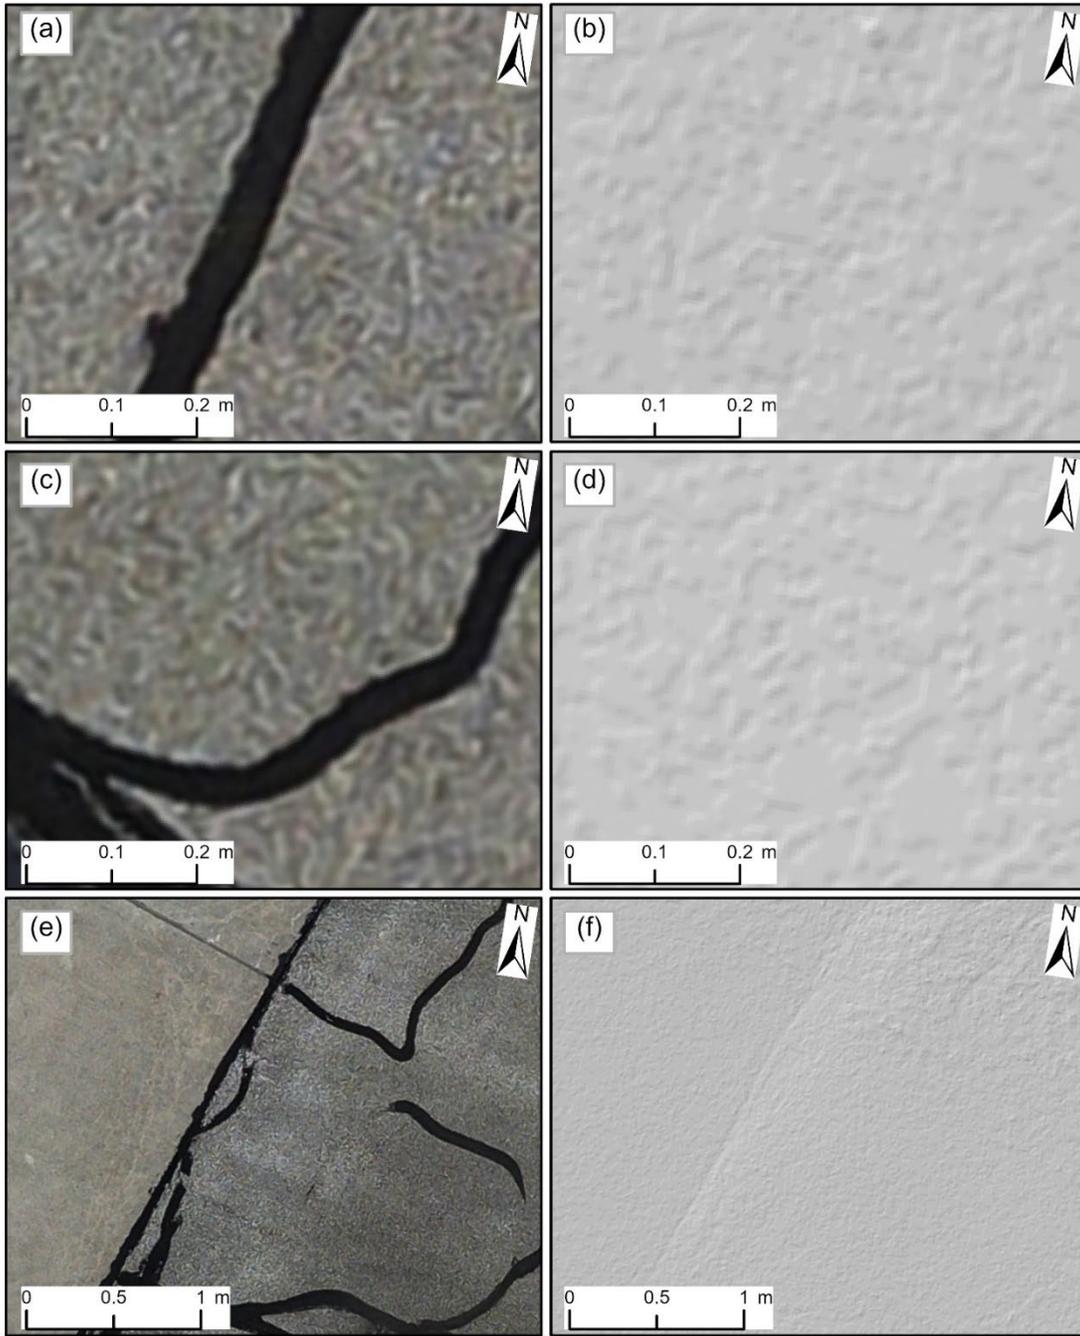
Figure 30. Low-severity L&T Cracks in (a) 2.5-mm/pix Orthophoto and (b) 4.9-mm/pix DEM; Medium-severity L&T Cracks in (c) 2.5-mm/pix Orthophoto and (d) 4.9 mm/pix DEM; and Low-severity Shoving in (e) 2.5-mm/pix Orthophoto and (f) 4.9-mm/pix DEM

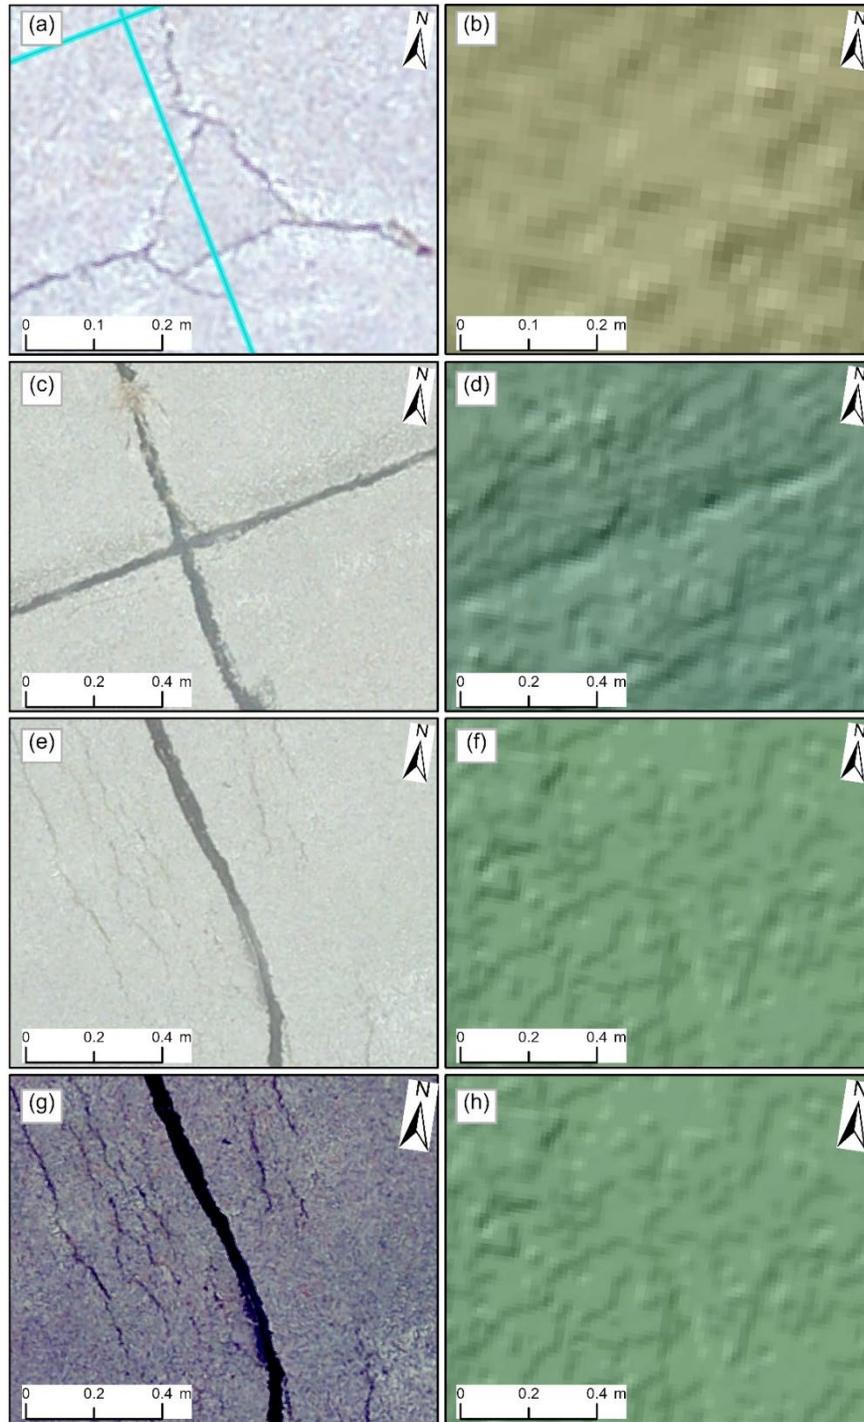
Figure 31. Low-severity L&T Cracks in (a) 3.6-mm/pix Orthophoto and (b) 14.3-mm/pix DEM; Medium-severity L&T Cracks in (c) 3.6-mm/pix Orthophoto and (d) 14.3-mm/pix DEM; Low-severity Shoving in (e) 3.6-mm/pix Orthophoto and (f) 14.3-mm/pix DEM; and High-severity L&T Cracks in (g) 2.5-mm/pix Orthophoto and (h) 4.9-mm/pix DEM

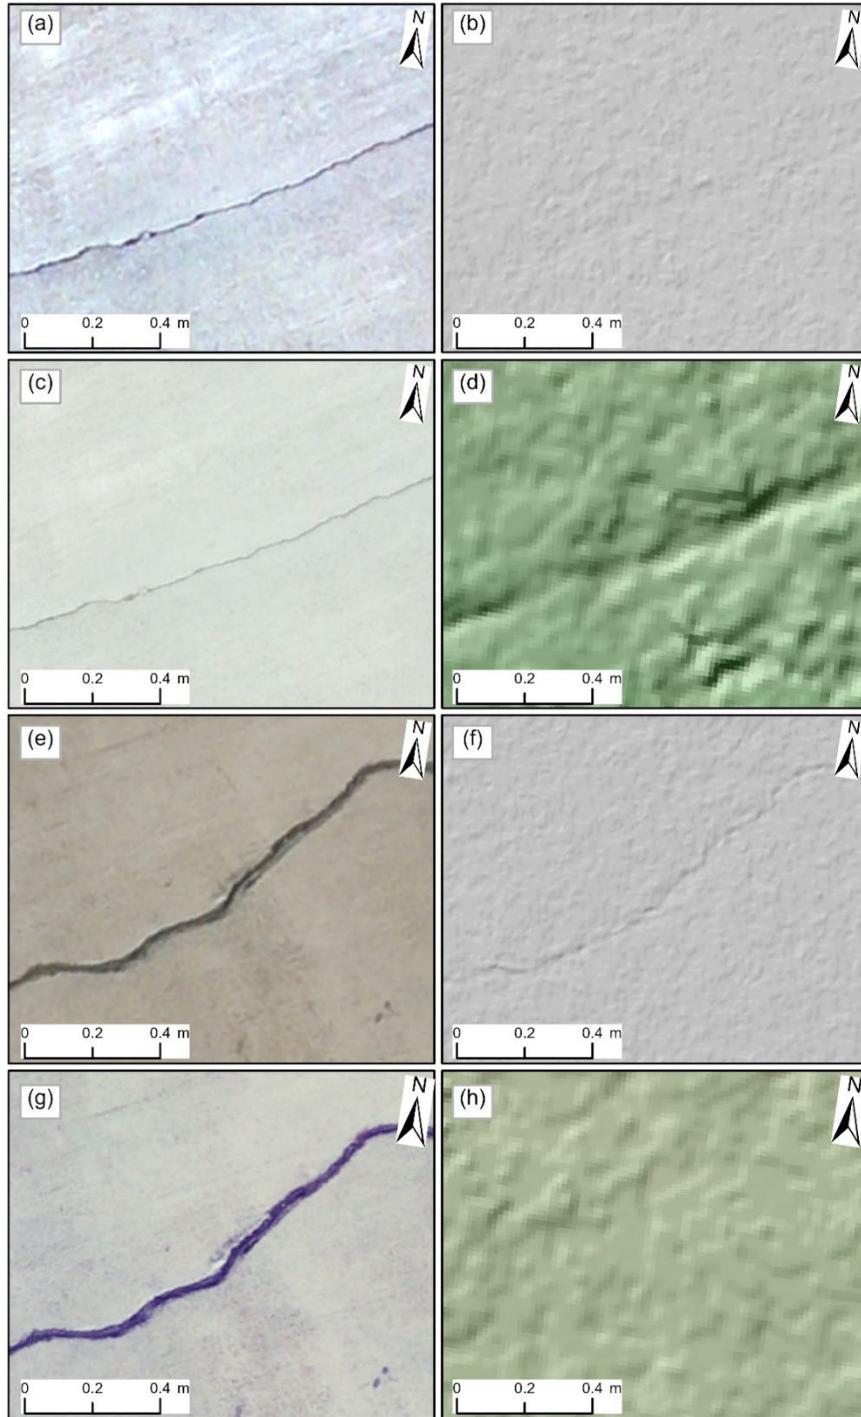
Figure 32. Low-severity LTD Cracks in (a) 2.5-mm/pix Orthophoto and (b) 4.9-mm/pix DEM, (c) 3.6-mm/pix Orthophoto and (d) 14.3-mm/pix DEM; and Medium-severity LTD Cracks in (e) 2.5-mm/pix Orthophoto, (f) 4.9-mm/pix DEM, (g) 2.5-mm/pix Orthophoto, and (h) 4.9-mm/pix DEM

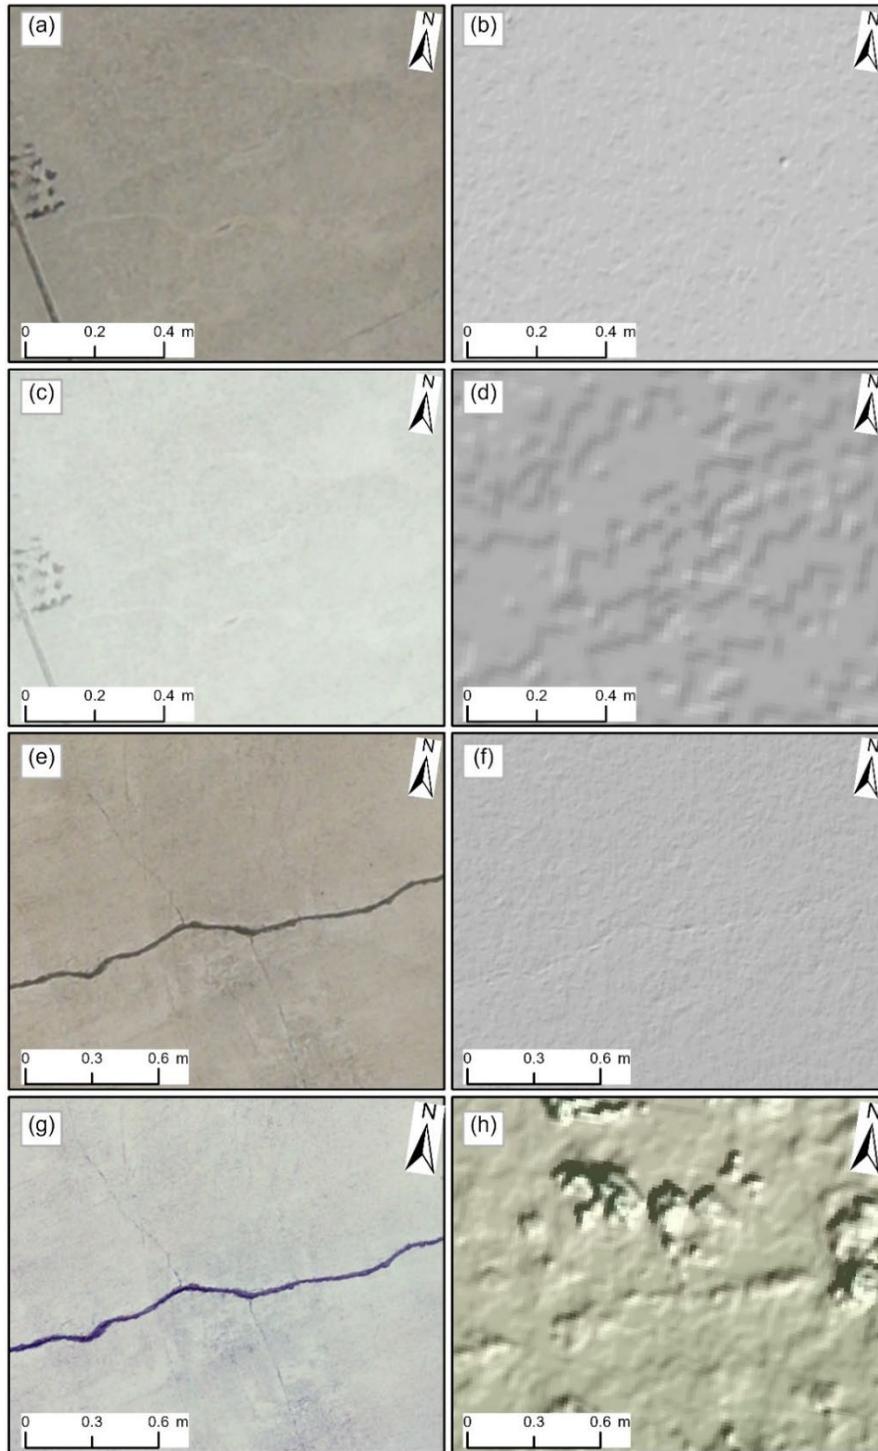
Figure 33. Low-severity Shrinkage Cracks in (a) 2.5-mm/pix Orthophoto and (b) 4.9-mm/pix DEM, (c) 3.6-mm/pix Orthophoto and (d) 14.3-mm/pix DEM; and Medium-severity Shattered Slab in (e) 2.5-mm/pix Orthophoto, (f) 4.9-mm/pix DEM, (g) 2.5-mm/pix Orthophoto, and (h) 4.9-mm/pix DEM

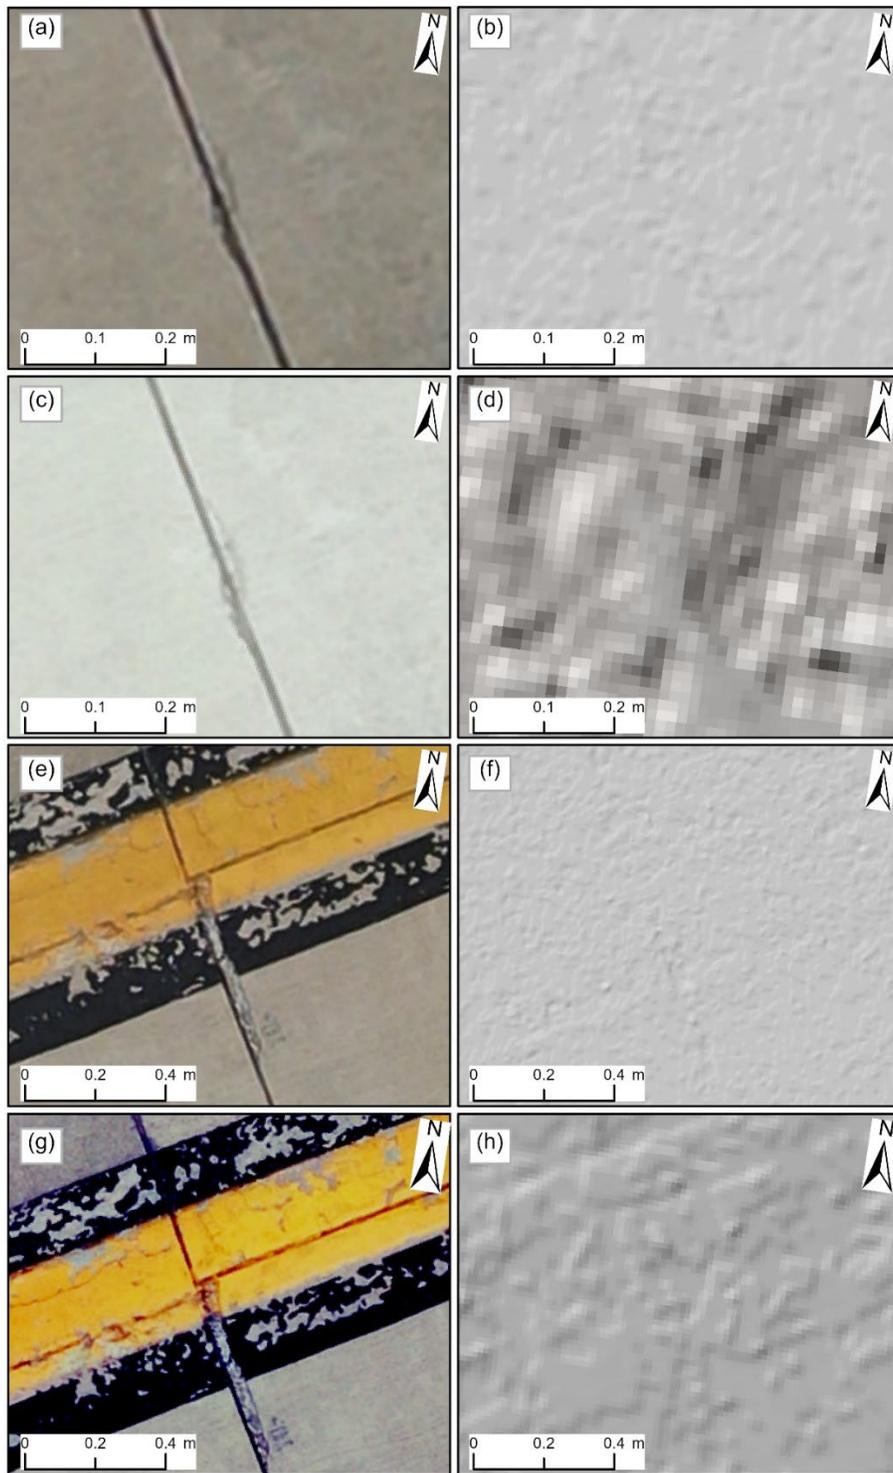
Figure 34. Low-severity Joint Spalling in (a) 2.5-mm/pix Orthophoto and (b) 4.9-mm/pix DEM, (c) 3.6-mm/pix Orthophoto and (d) 14.3-mm/pix DEM; and Medium-severity Joint Spalling in (e) 2.5-mm/pix Orthophoto, (f) 4.9-mm/pix DEM, (g) 2.5-mm/pix Orthophoto, and (h) 4.9-mm/pix DEM Derived

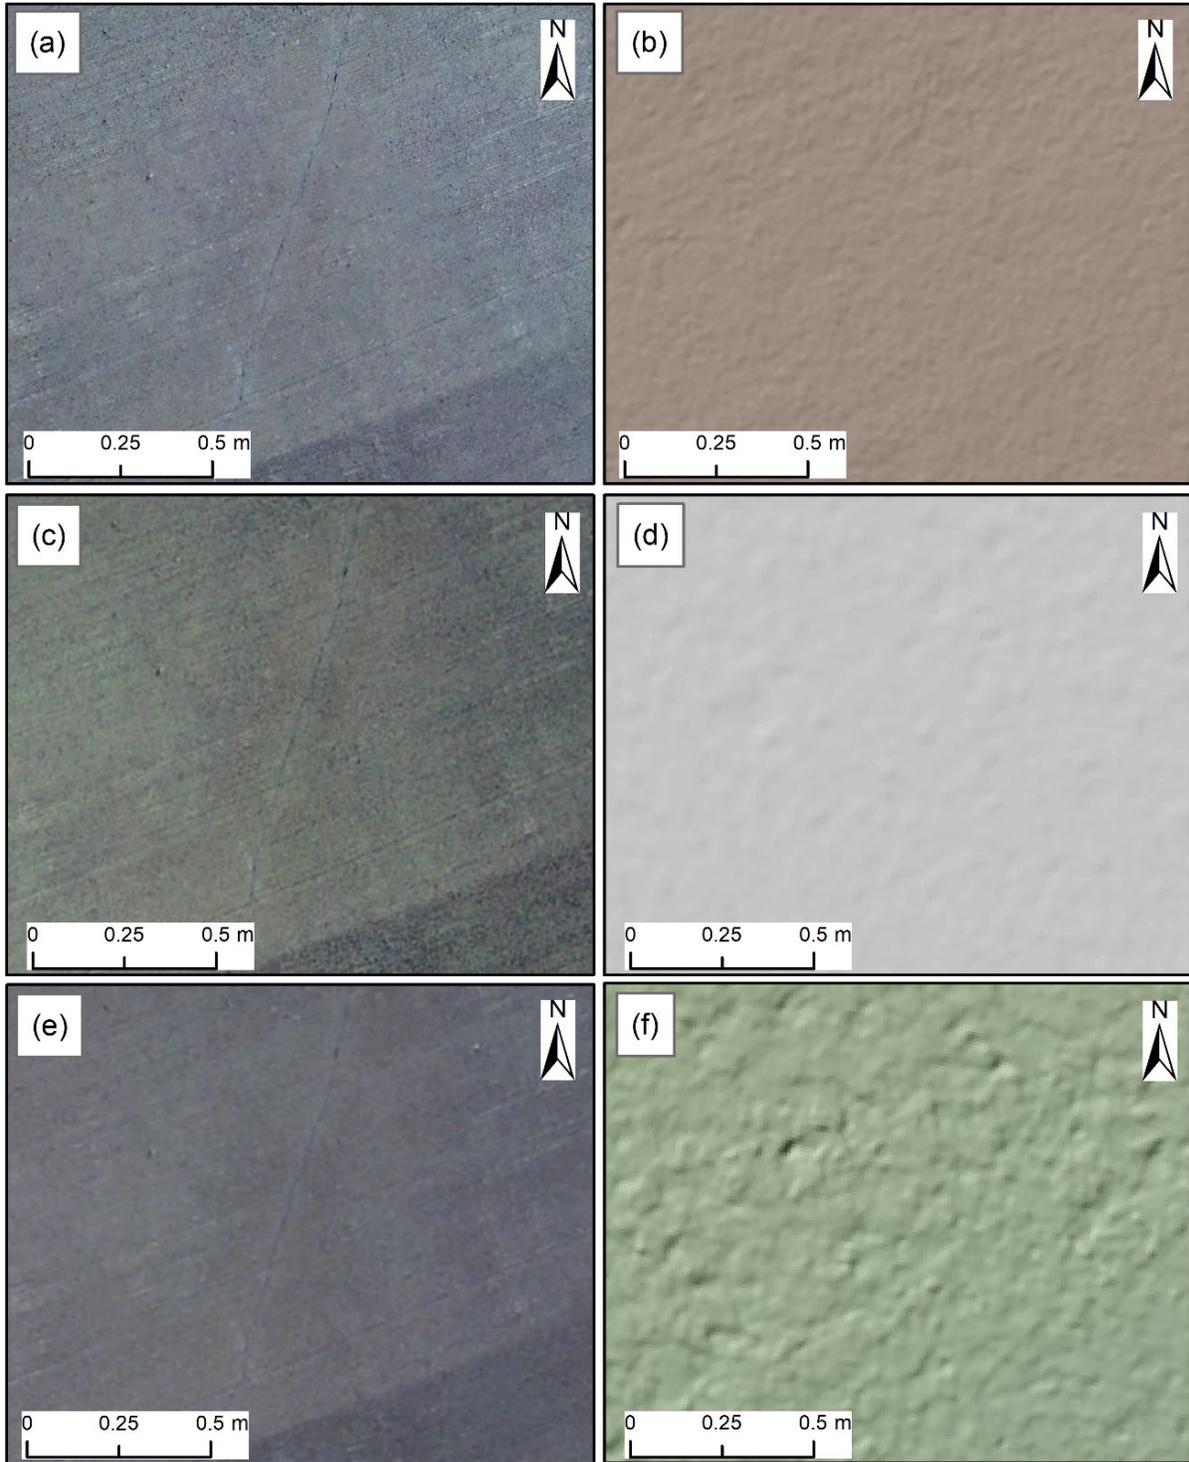
Figure 39. Low-severity LTD Cracks in (a) 1.5-mm/pix Orthophoto, (b) 6.1-mm/pix DEM, (c) 3.3-mm/pix Orthophoto, (d) 13.5-mm/pix DEM, (e) 2.4-mm/pix Orthophoto, and (f) 9.5-mm/pix DEM

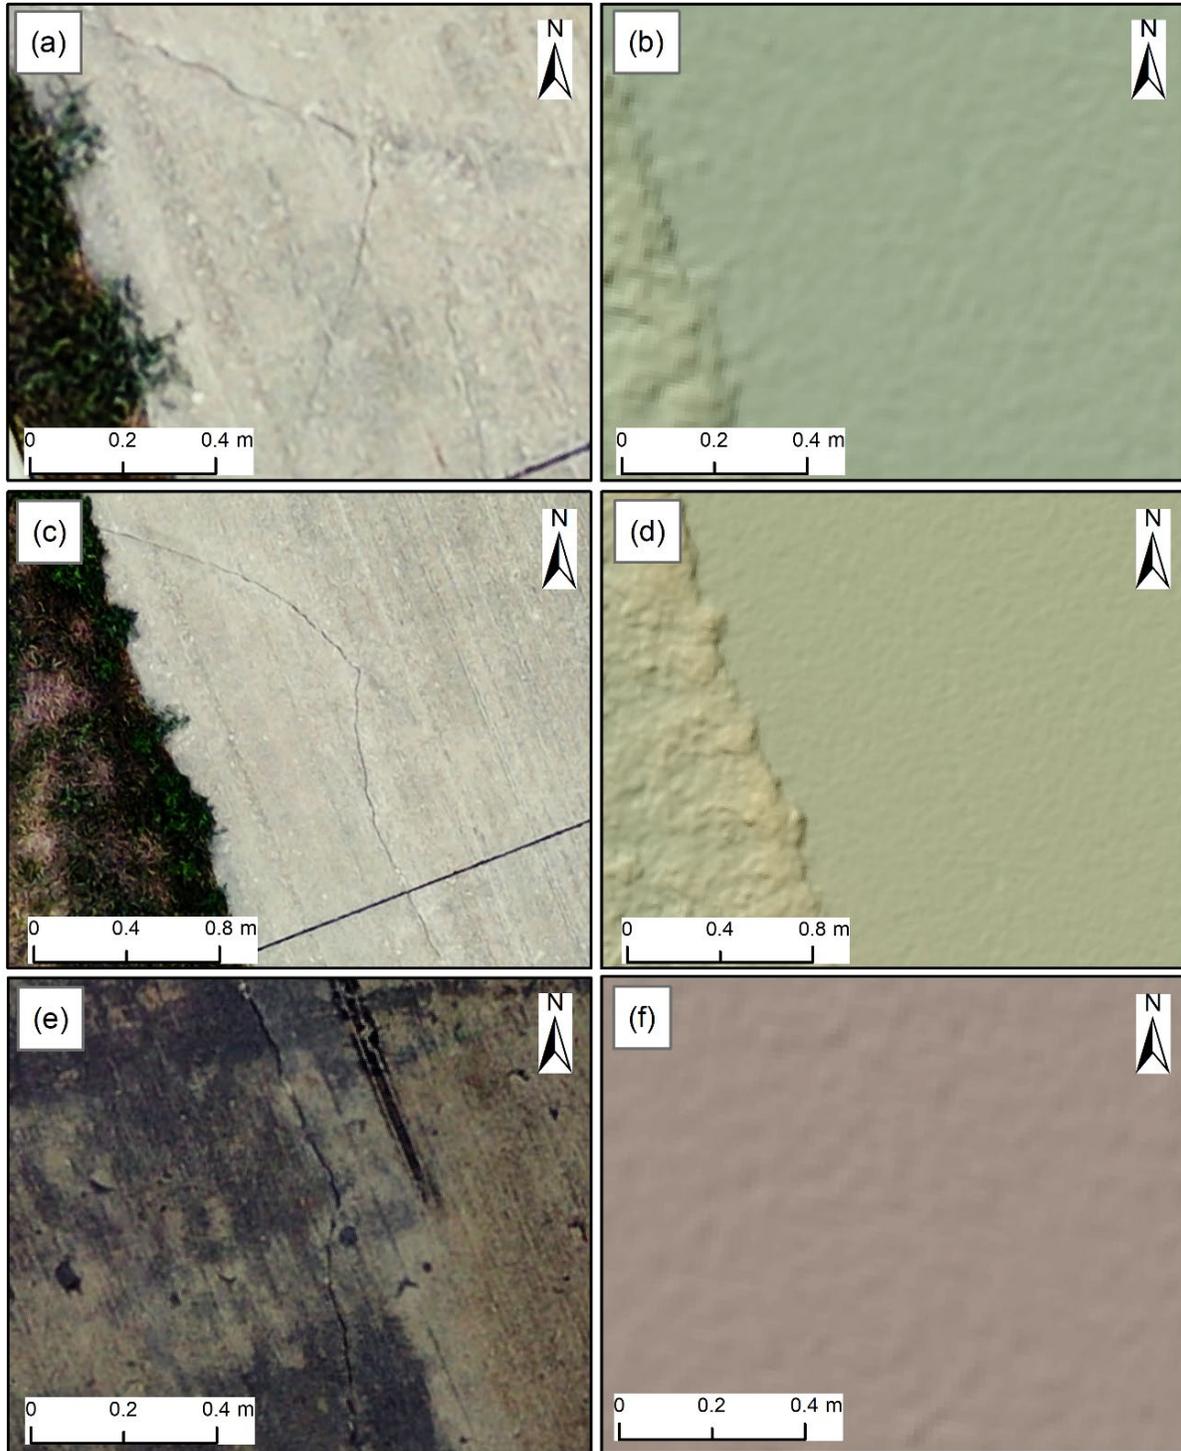
Figure 40. Medium-severity Corner Break in (a) 2.4-mm/pix Orthophoto and (b) 9.5-mm/pix DEM; and Medium-severity LTD cracks in (c) 2.4-mm/pix Orthophoto, (d) 9.5-mm/pix DEM, (e) 3.3-mm/pix Orthophoto, and (f) 13.5-mm/pix DEM

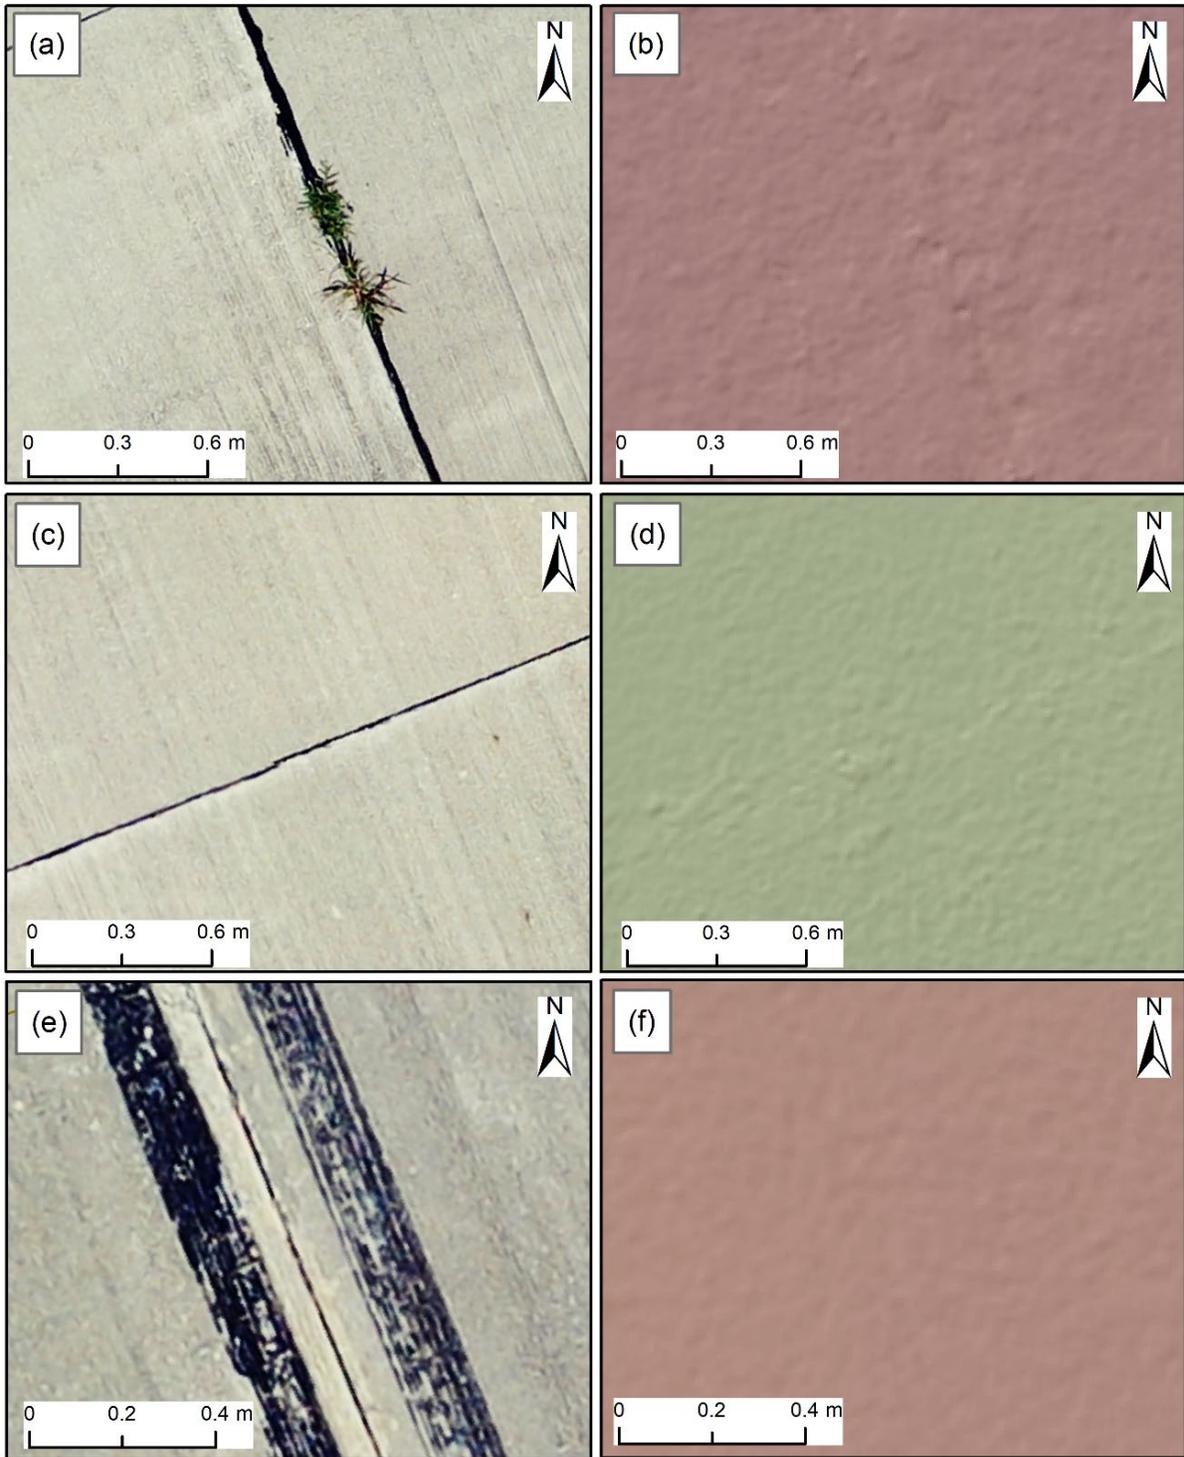
Figure 41. High-severity Joint Seal Damage in (a) 2.4-mm/pix Orthophoto and (b) 9.5-mm/pix DEM; and Low-severity Faulting in (c) 2.4-mm/pix Orthophoto and (d) 9.5-mm/pix DEM; and Shrinkage Cracking in (e) 2.4-mm/pix Orthophoto and (f) 9.5-mm/pix DEM

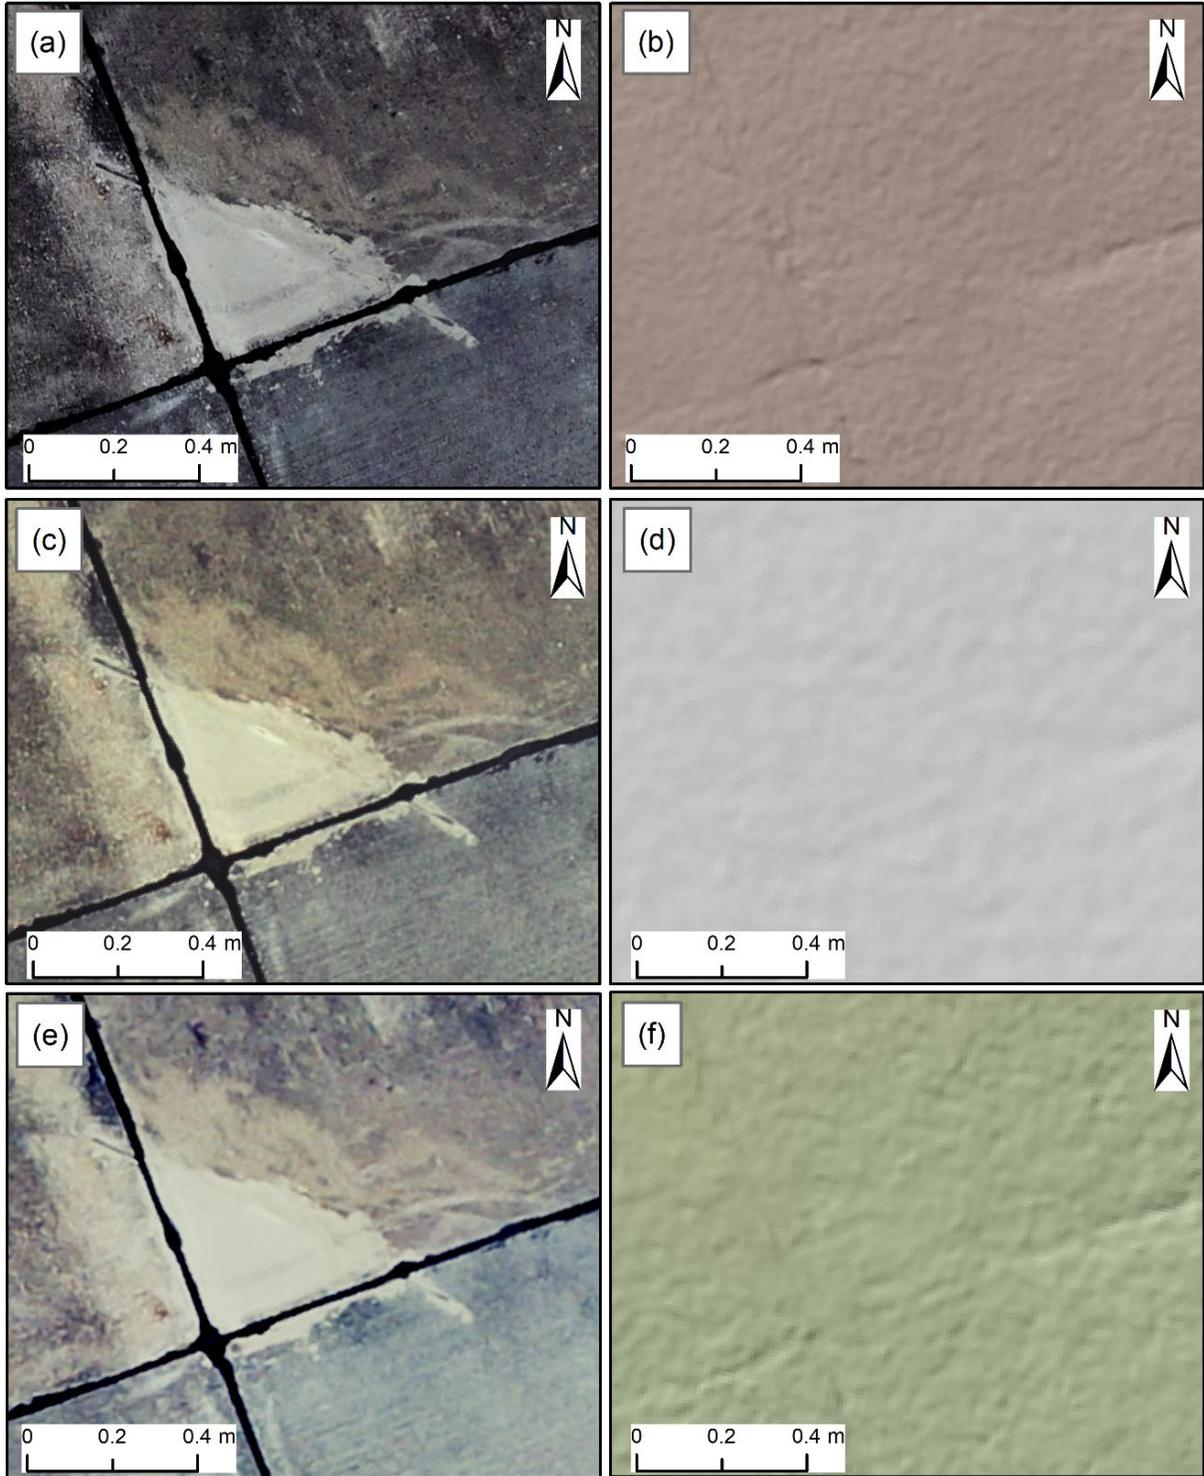
Figure 42. Low-severity Small Patching in (a) 1.5-mm/pix Orthophoto, (b) 6.1-mm/pix DEM, (c) 3.3-mm/pix Orthophoto, (d) 13.5-mm/pix DEM, (e) 2.4-mm/pix Orthophoto, and (f) 9.5-mm/pix DEM

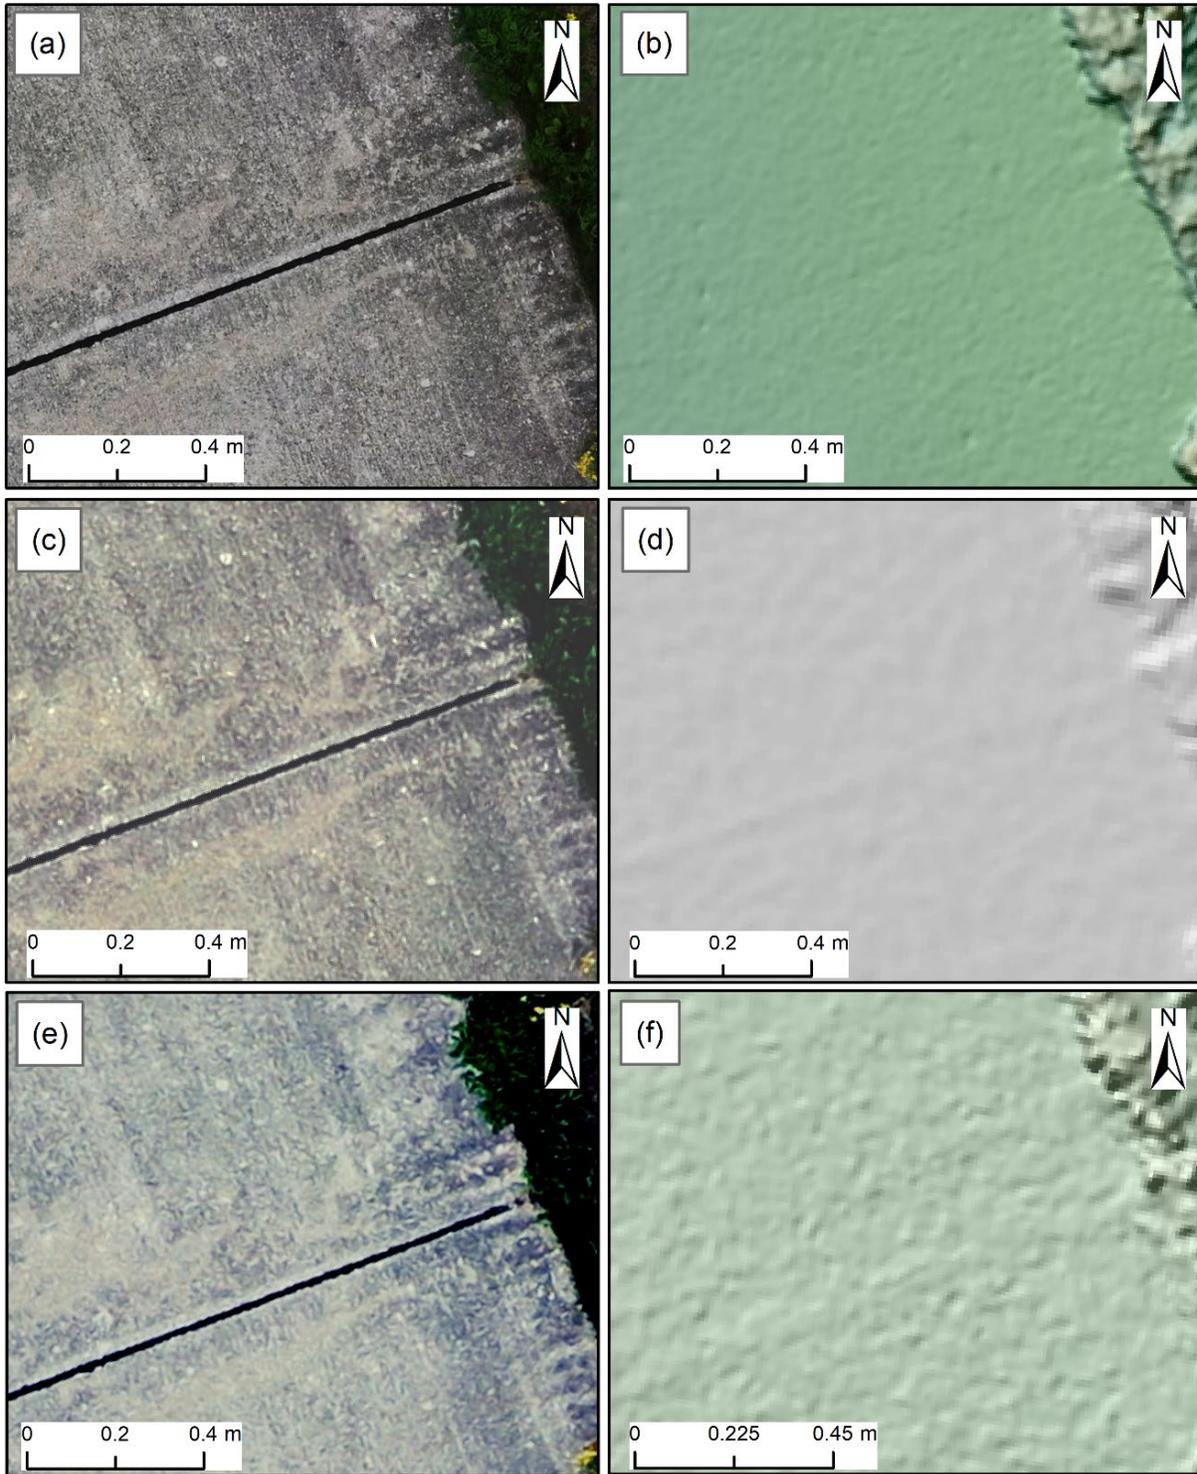
Figure 46. Low-severity Corner Spalling in (a) 1.5-mm/pix Orthophoto, (b) 6.1-mm/pix DEM, (c) 3.3-mm/pix Orthophoto, (d) 13.5-mm/pix DEM, (e) 2.4-mm/pix Orthophoto, and (f) 9.5-mm/pix DEM

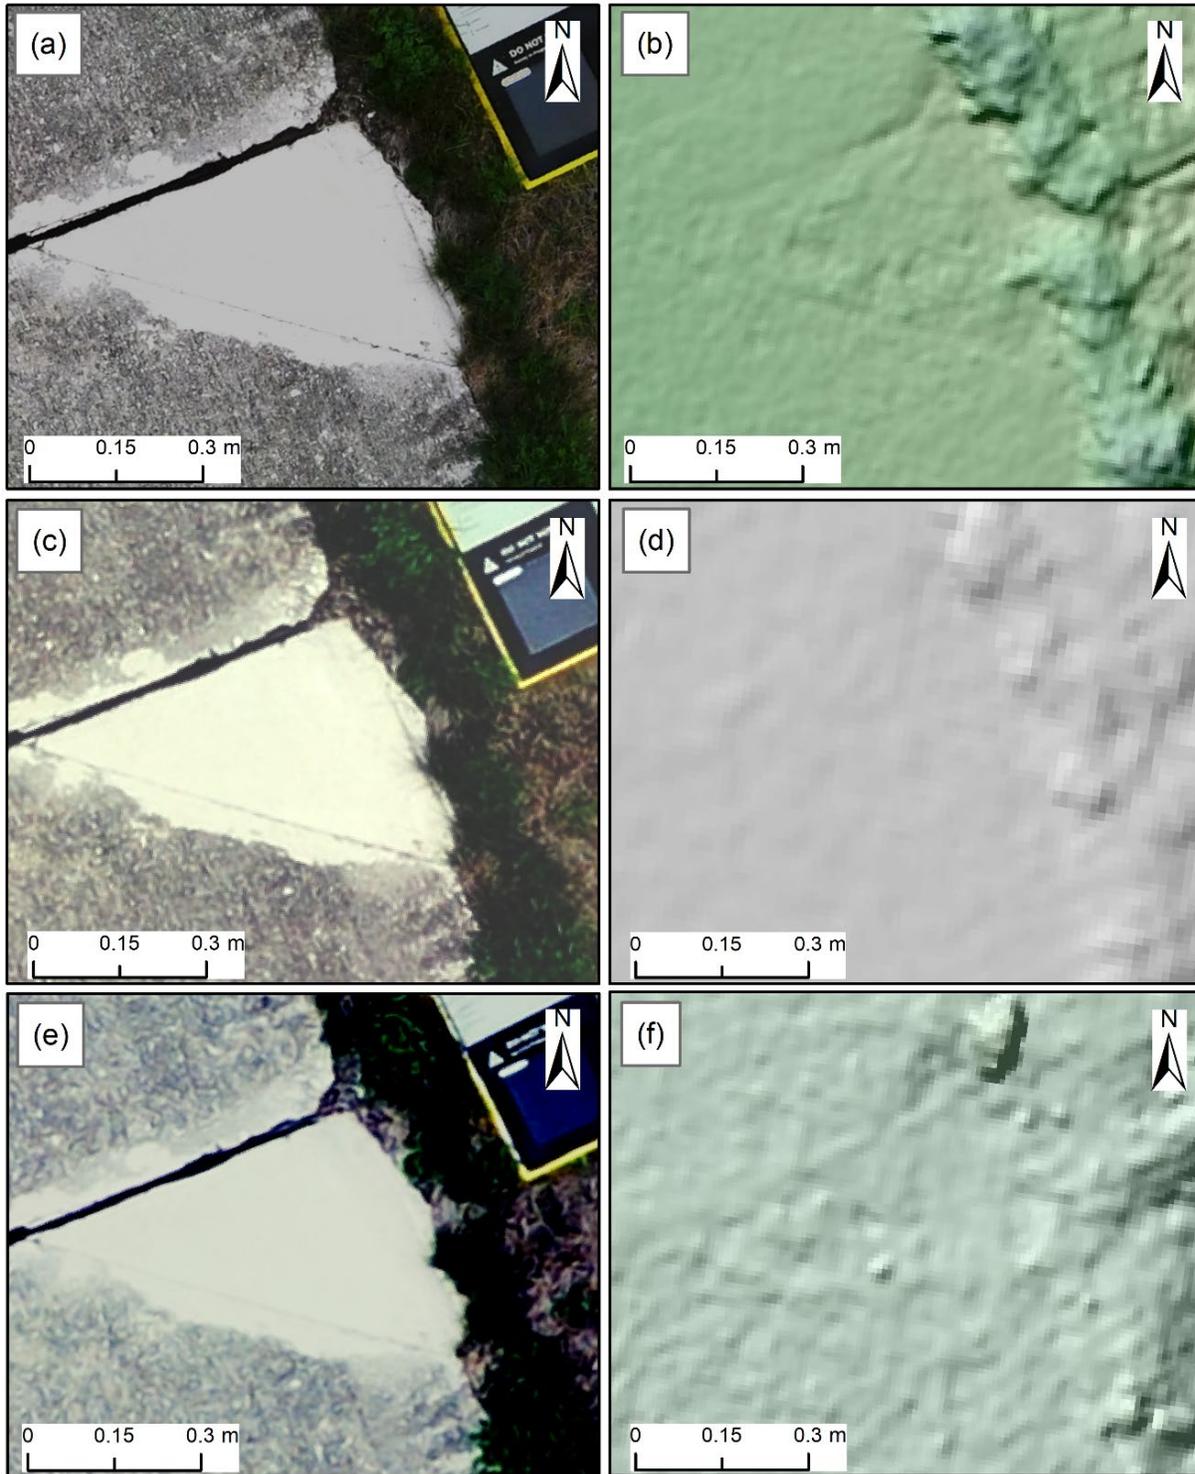
Figure 47. Low-severity Small Patching and Medium-severity Corner Spalling in (a) 1.5-mm/pix Orthophoto, (b) 6.1-mm/pix DEM, (c) 3.3-mm/pix Orthophoto, (d) 13.5-mm/pix DEM, (e) 2.4-mm/pix Orthophoto, and (f) 9.5-mm/pix DEM

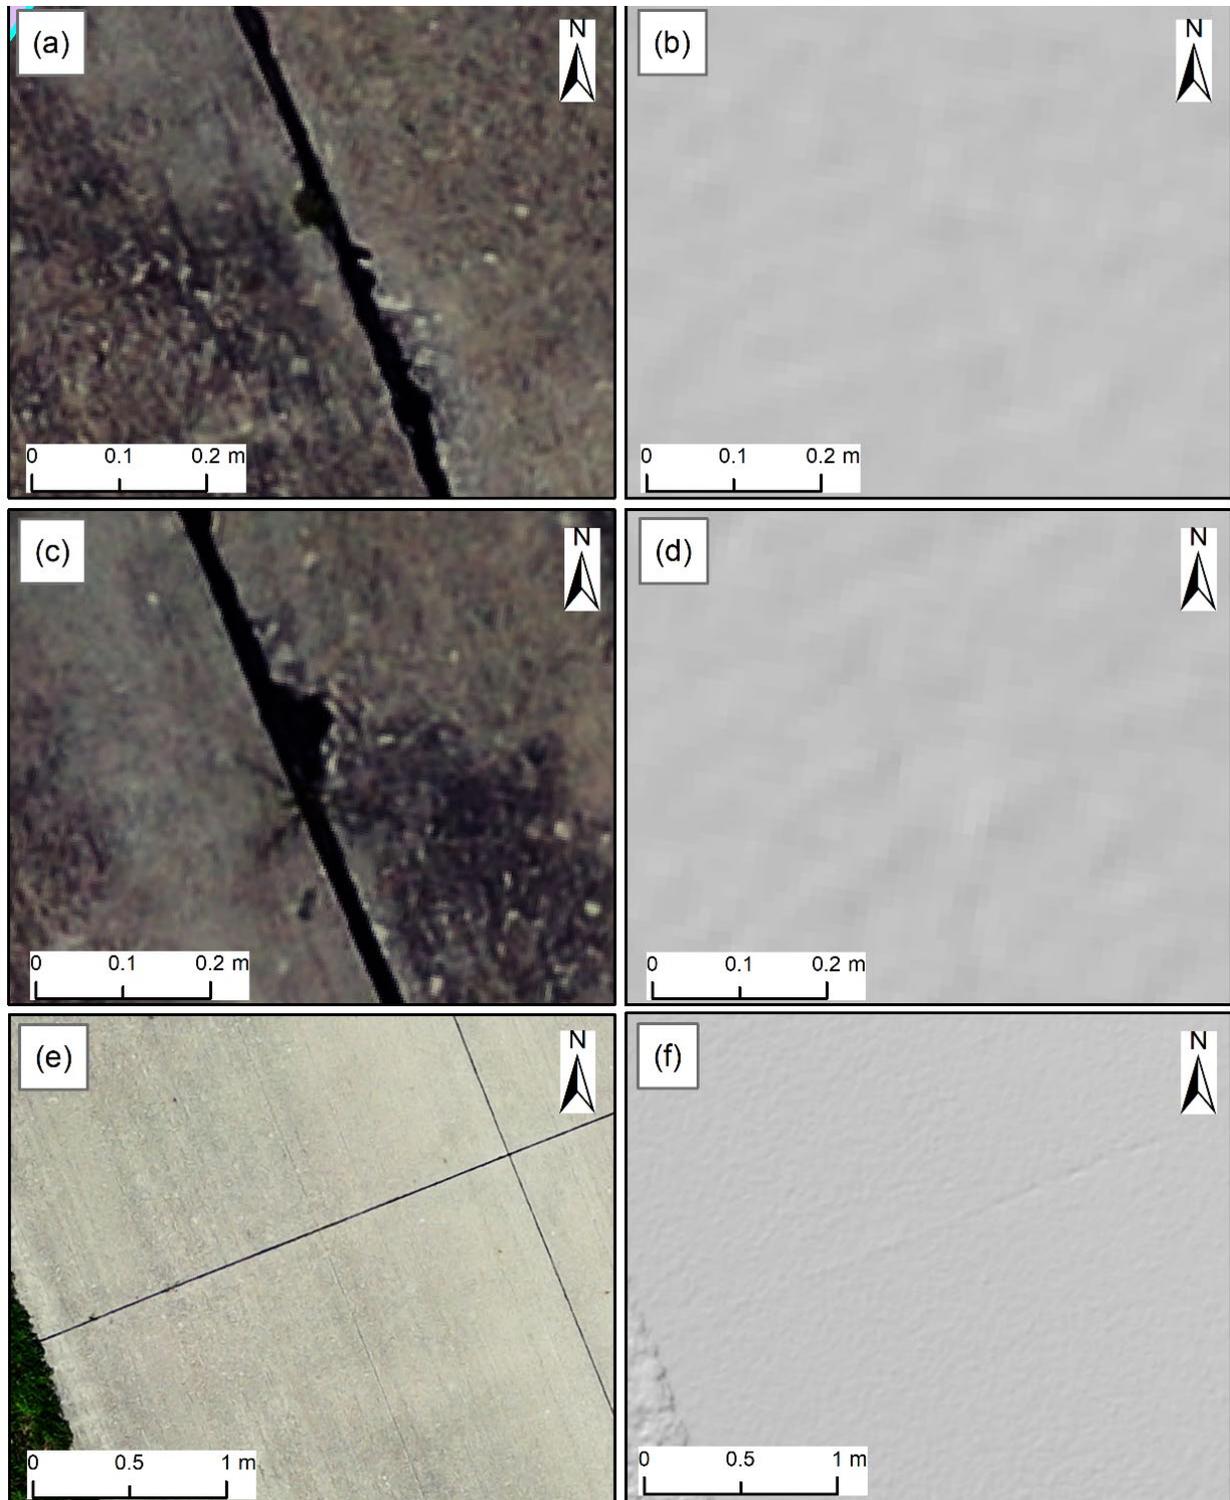
Figure 48. Low-severity Joint Spalling in (a) 3.3-mm/pix Orthophoto and (b) 13.5-mm/pix DEM; Medium-severity Joint Spalling in (c) 3.3-mm/pix Orthophoto and (d) 13.5-mm/pix DEM; and Medium-severity Joint Seal Damage in (e) 2.4-mm/pix Orthophoto and (f) 9.5-mm/pix DEM

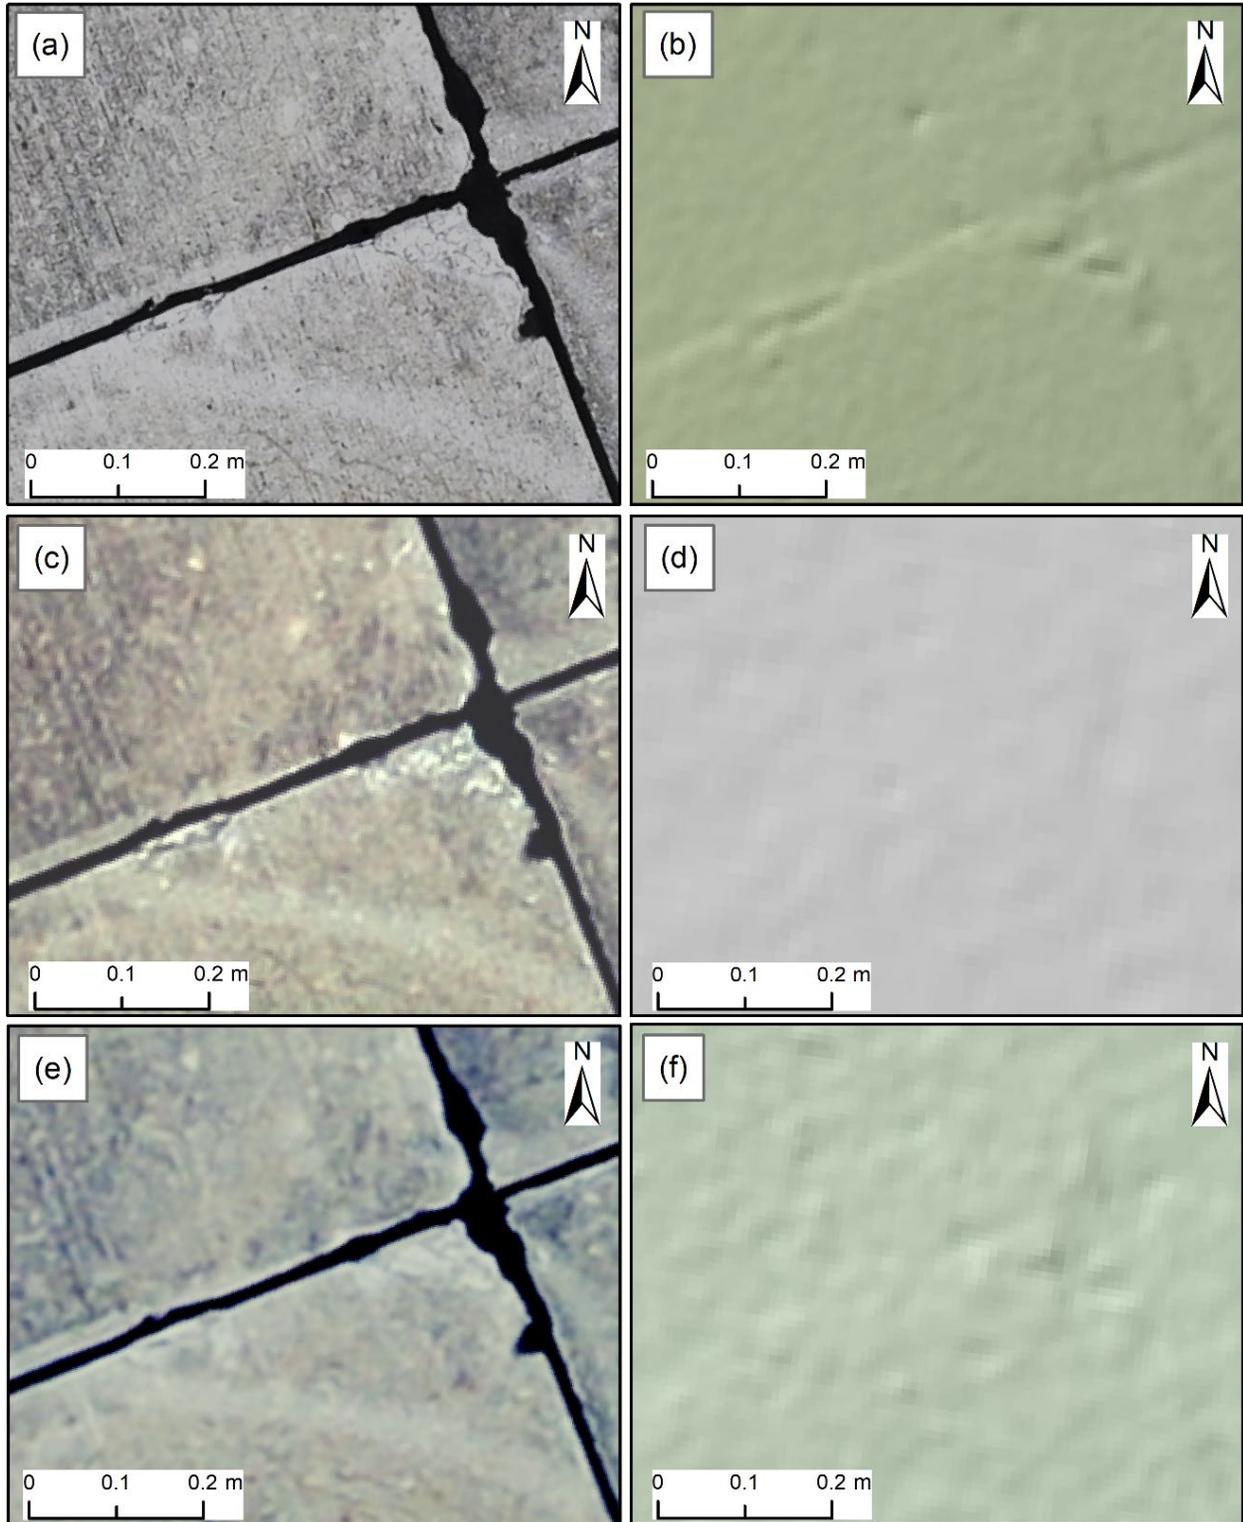
Figure 49. Medium-severity ASR in (a) 1.5-mm/pix Orthophoto, (b) 6.1-mm/pix DEM, (c) 3.3-mm/pix Orthophoto, (d) 13.5-mm/pix DEM, (e) 2.4-mm/pix Orthophoto, and (f) 9.5-mm/pix DEM
